# The Royal Crescent Ha-ha

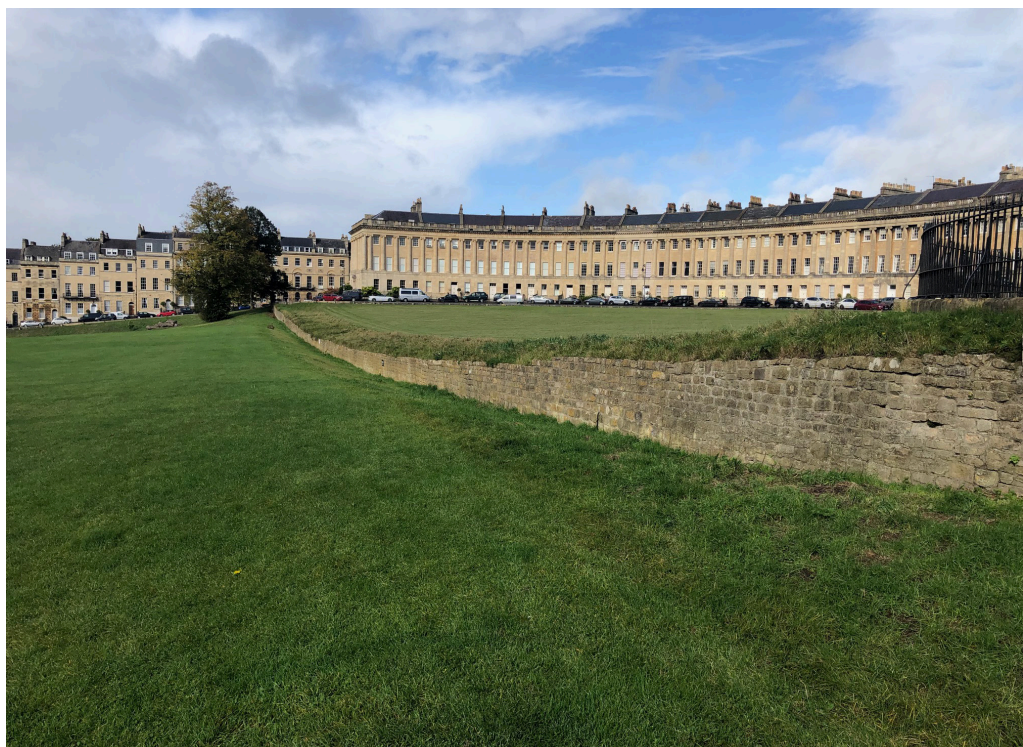
Now you see it.....  
Royal Crescent ha-ha from the south

It is a construction comprising a stone wall and ditch designed to create a boundary which does not interrupt the view, and is more usually to be found in settings such as rural parkland to control the movements of livestock. This design originated in France in the early 18th century and the idea of such an invisible boundary spread to England later that century. The etymology of the word, which came from the French name and was also known as a hawhaw, is the subject of several theories: it may originate from the expression of surprise, ha! ha!, that one might make on suddenly coming across such an obstacle; another theory is that it is a contraction of half-ditch and half-wall.

Fragments of glass and pottery showed that this infilling started to happen over 200 years previously. It was also discovered that the wall was built without foundations, but directly on the clay bed. Some traces of lime mortar were found in the lower courses of the wall, but dry-stone construction was used for the majority of the wall, with no mortar to impede drainage of water from the lawn. The wall was a facing for the stable clay behind it rather than a revetment holding back a large volume of soil, except at either end where it was higher and required some mortar to strengthen it where it adjoins the road.

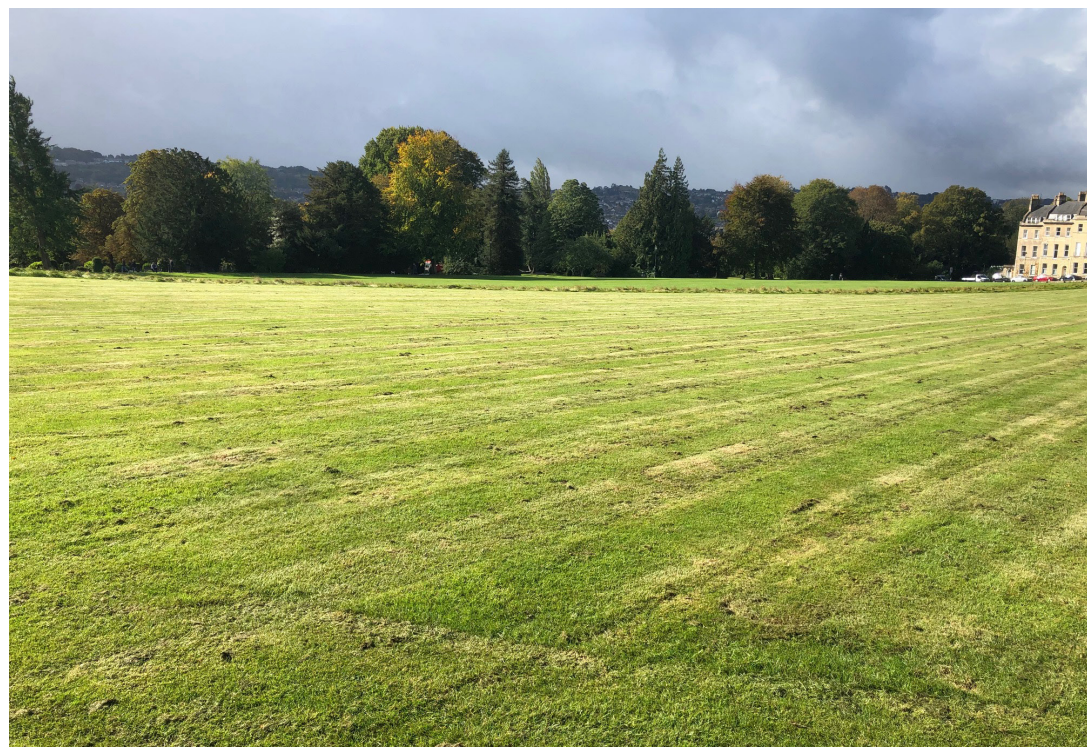
.....Now you don't  
Royal Crescent ha-ha from the north
