# The Royal Crescent Ha-ha

Stephen Little

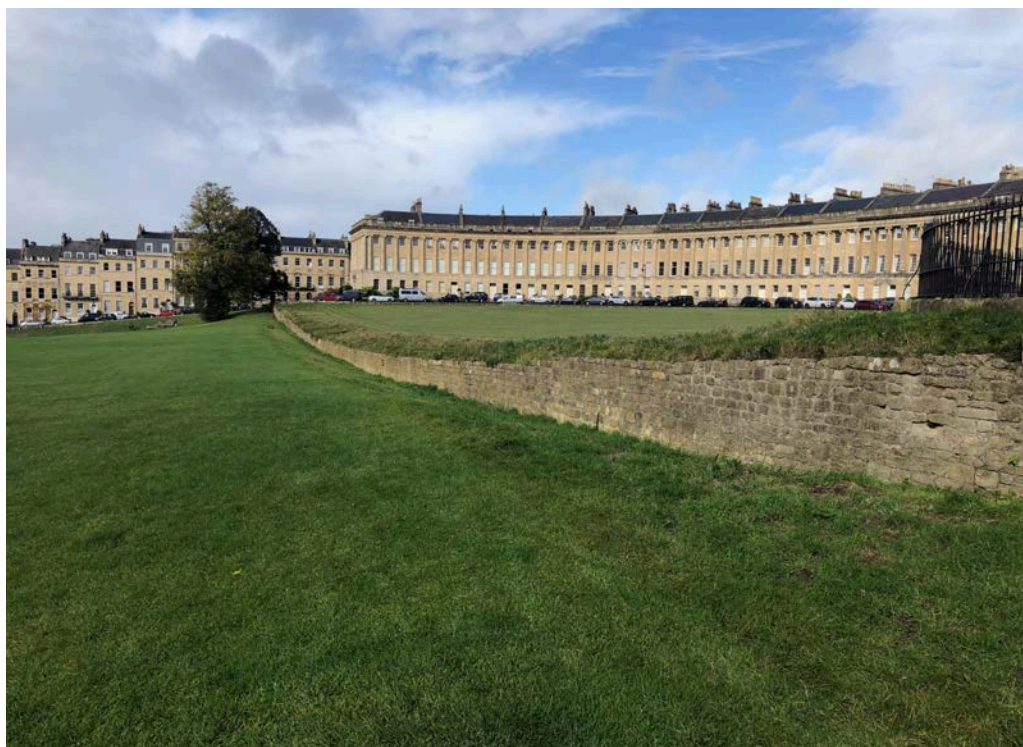
Now you see it.....  
Royal Crescent ha-ha from the south

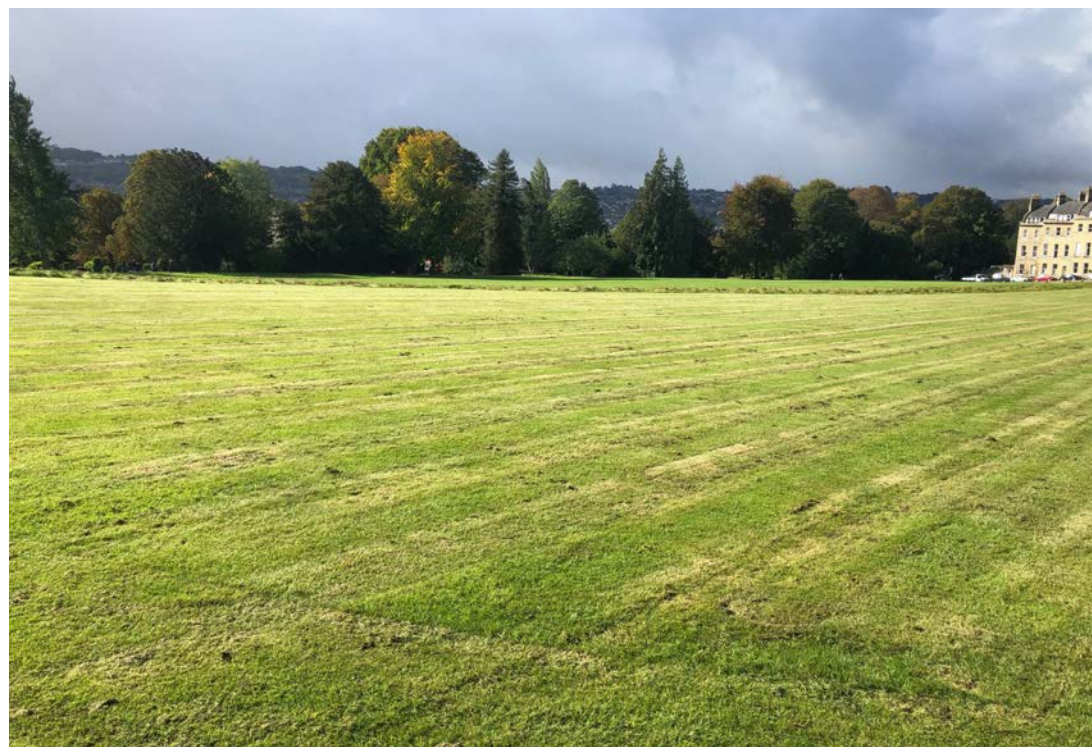
.....Now you don't  
Royal Crescent ha-ha from the north
